STONETON
Betterton, Maryland
(ca 1890-95)

K-446

INVENTORY FORM FOR STATE HISTORIC SITES SURVEY

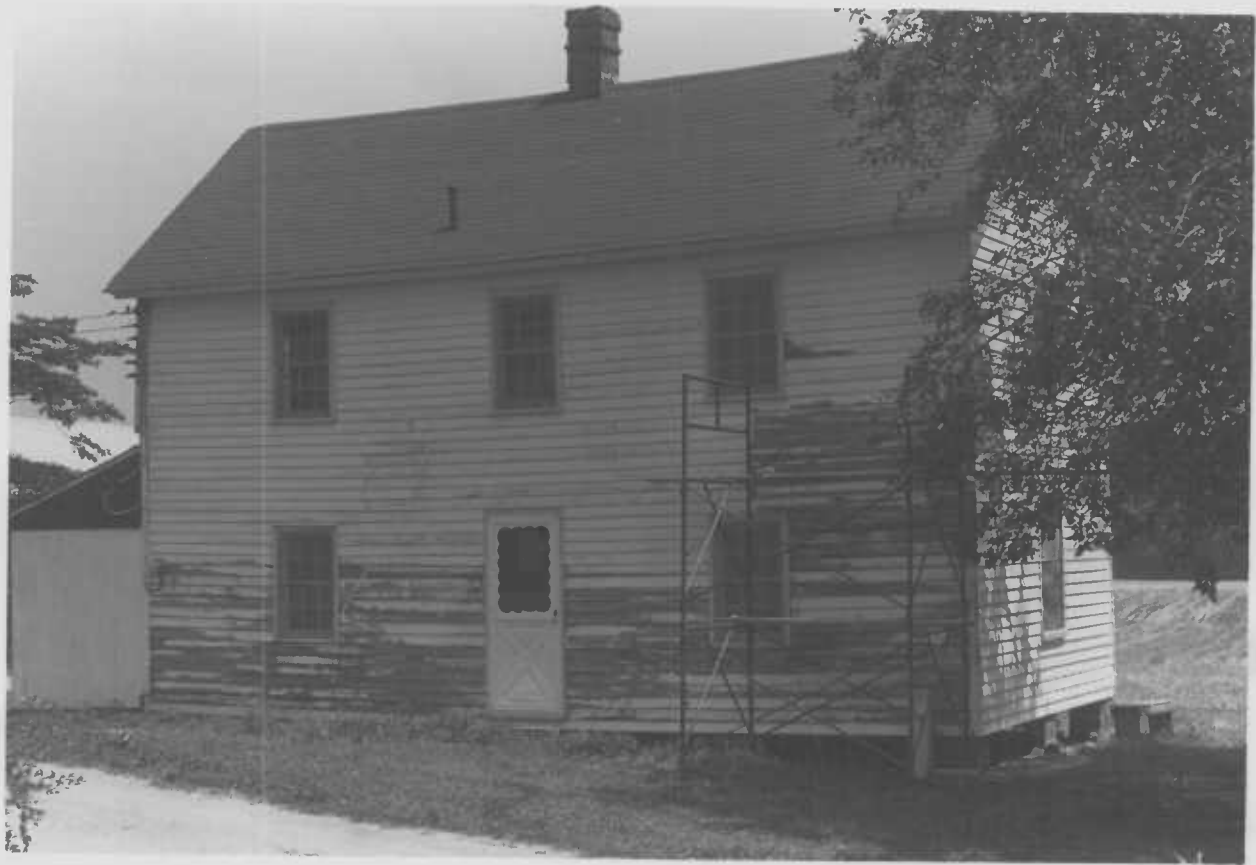
View to East

The tenant house on the property is two stories tall, three bays wide, and one bay deep. It rests on brick piers and has a gable roof with overhanging eaves. An earlier off-center chimney once served four fireplaces. The L-shaped stair runs behind the chimney mass. Although the house has been greatly altered through the years, it has some interior trim, stair and mantles with late Federal (ca 1810-20) detailing. The moldings have very small beads combined with Greek ogee profiles and split fascia. There is an eight panel door and a six panel door, and a turned stair newel.

Tenant House
